REQUEST FOR PROPOSAL FOR DESIGN ENGINEERING & CONSTRUCTION SERVICES

Replacement of:

SN 6682,

Darr Road over North Branch Lincoln River, Sherman Township, Mason County

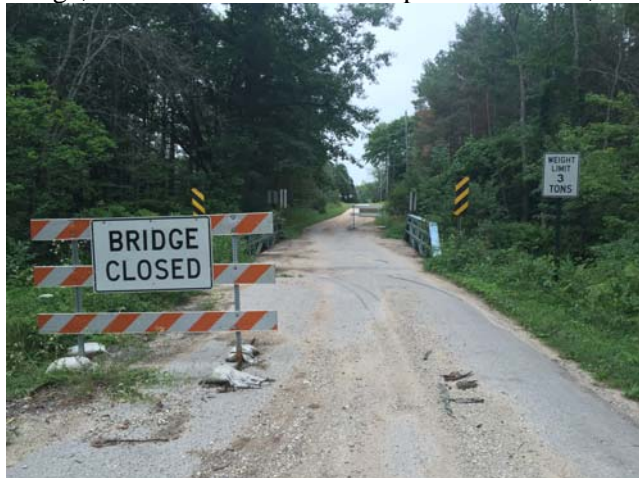
Figure 2 – View from approach

Darr Road near this crossing is 14 to 19 feet wide with a gravel surface. About ¼ mile south of the bridge, the road becomes an unimproved dirt trail, which crosses a drain via an impassable structure.

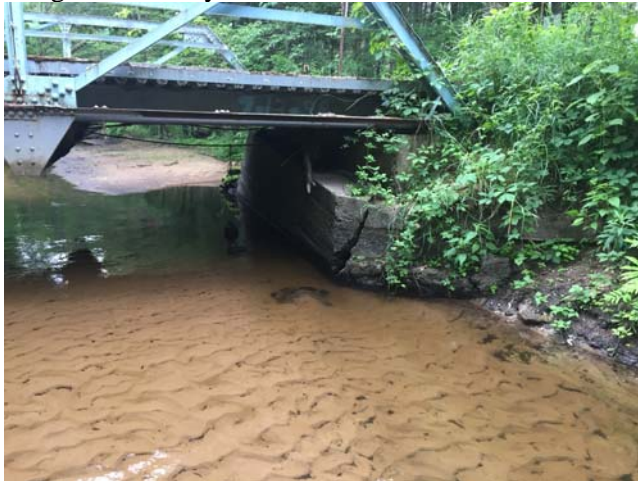
Figure 3 – View of abutment

The bridge is Structure #6682. According to its latest Bridge Safety Inspection Report (June, 2016), the bridge was constructed in 1900 and reconditioned in 1979. It is about 36 feet long with a width of 16 feet. It consists of bituminous paving on a steel deck, with a through-truss superstructure supported on concrete abutments. The Bridge Safety Inspection Report indicates the bridge is in very poor condition. Significant items of note include severe corrosion and section loss of stringers, gusset plates, and floor beams. The north abutment has significant cracks, leading to loss of ground behind the abutment. A significant scour hole has undermined a portion of the north abutment, which has moved and settled. The bridge is currently closed to traffic.

During our site visit, debris was noted in the superstructure, suggesting that high flows reach the elevation of the bridge.
