Fisher Road Bridge - Between Peterson Road & Victory
Corner Road - Victory Township, Mason County

Existing Bridge - Built early 1900's - Replaced Beams & Deck 1974

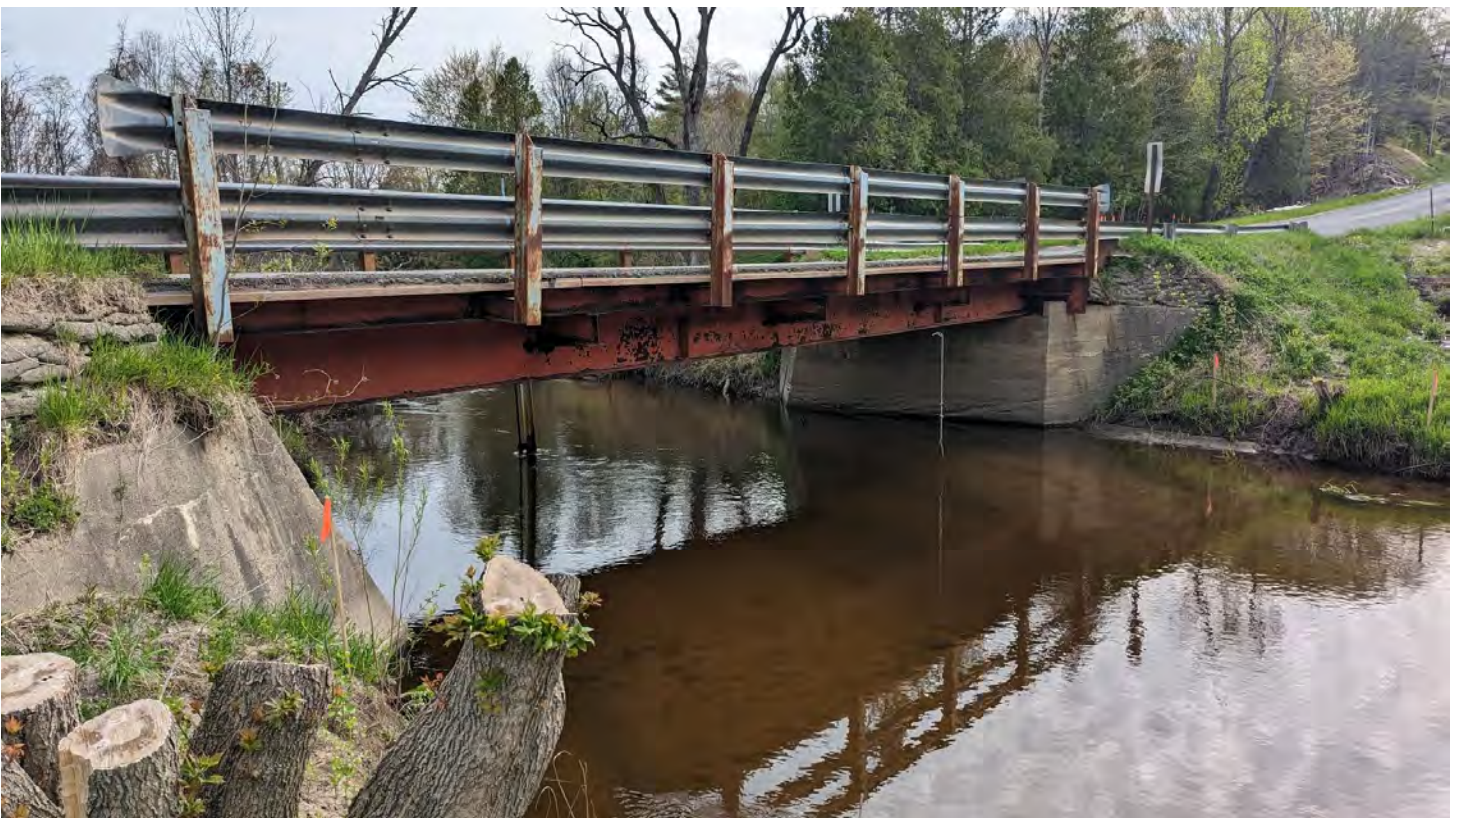
Removal of Old Bridge - May 2023

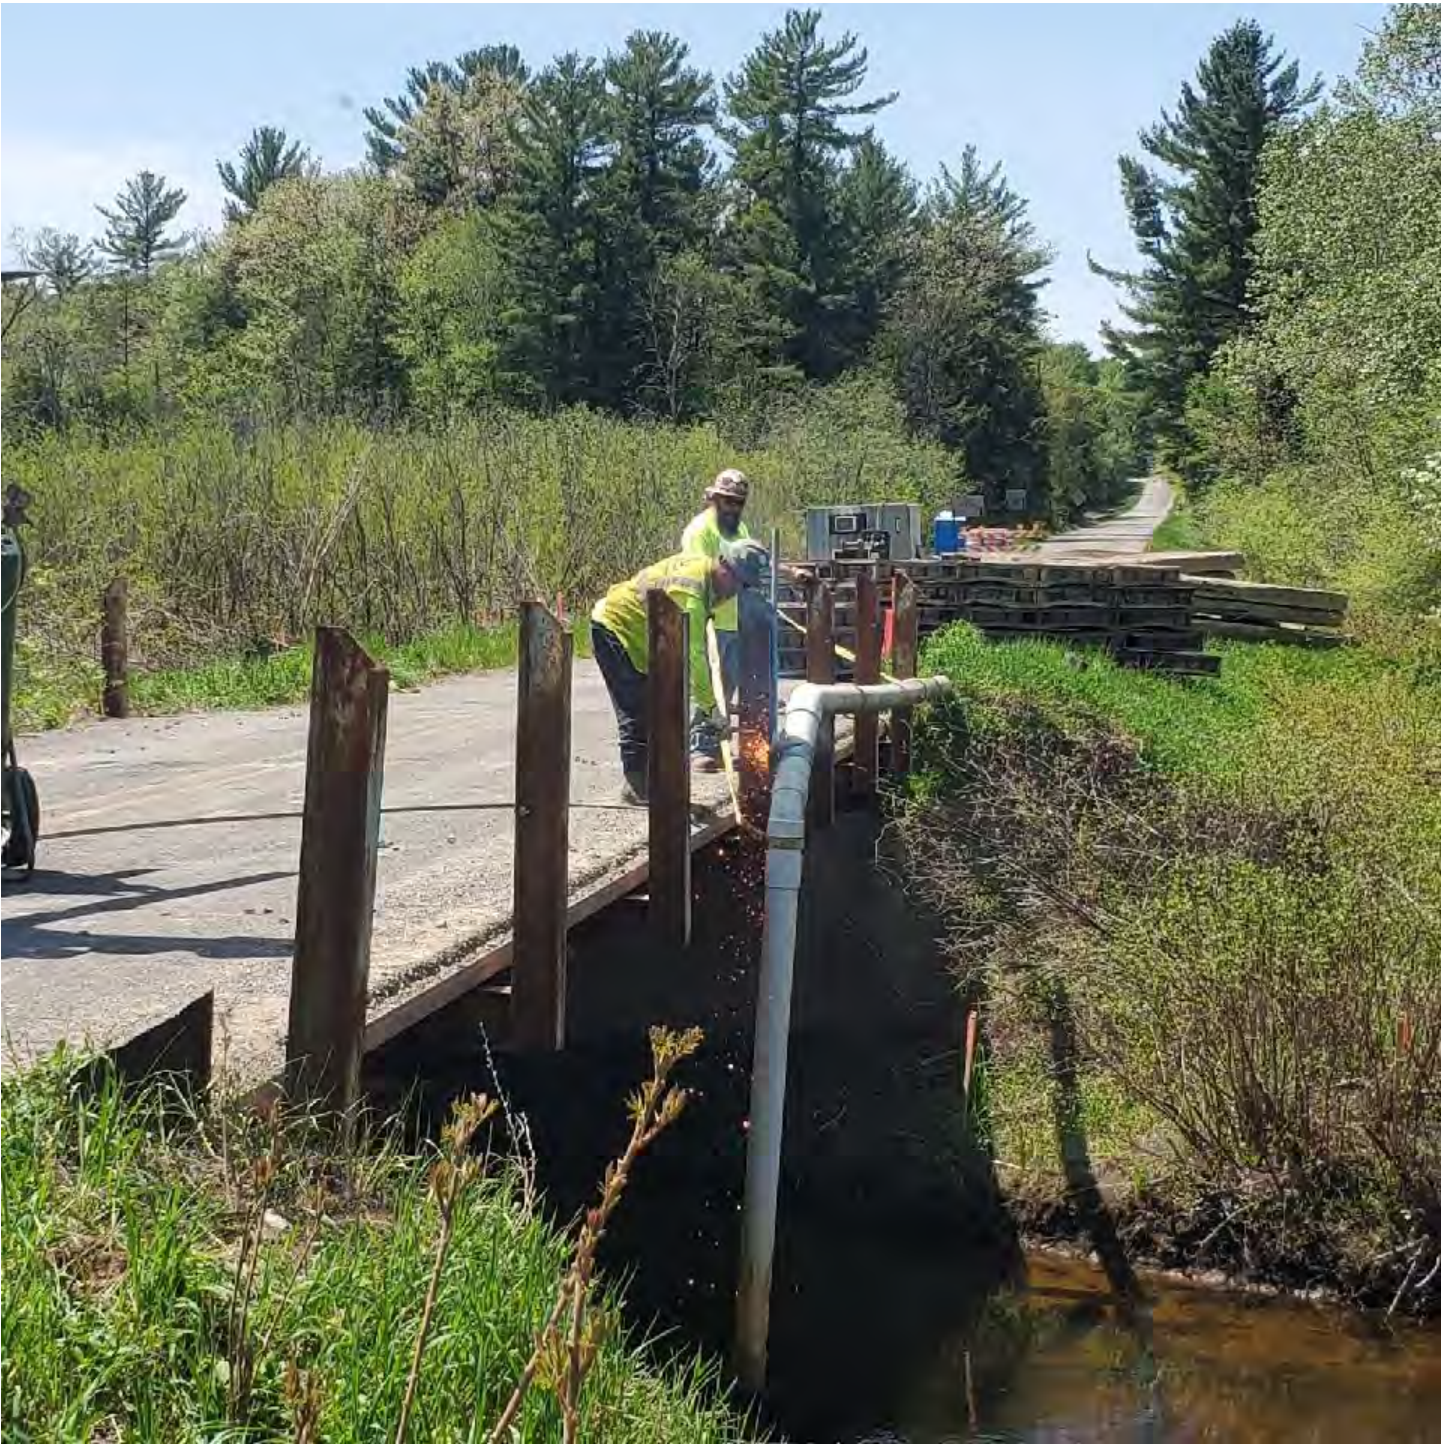
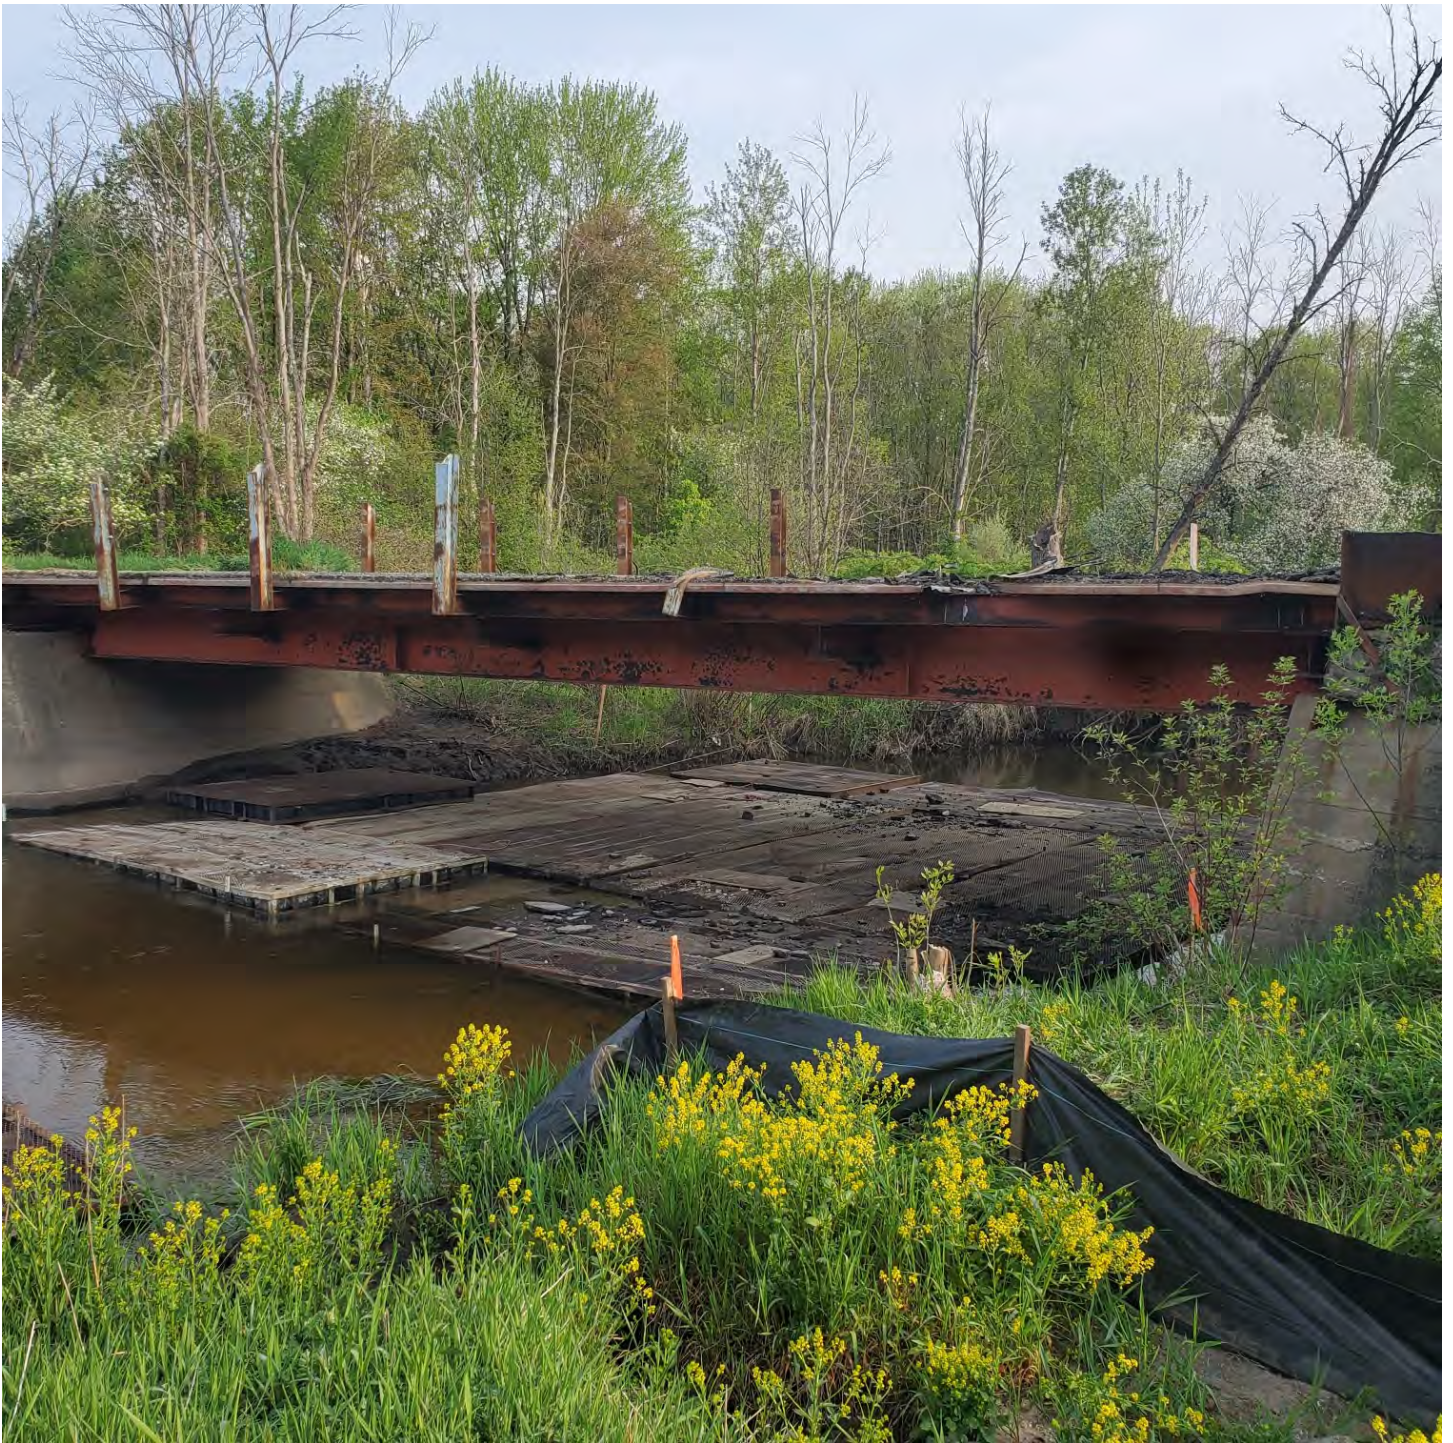
False Decking below bridge to catch any debris from falling into the Lincoln River

Removal of Old Bridge Deck - HMA on Corrugated Metal Deck

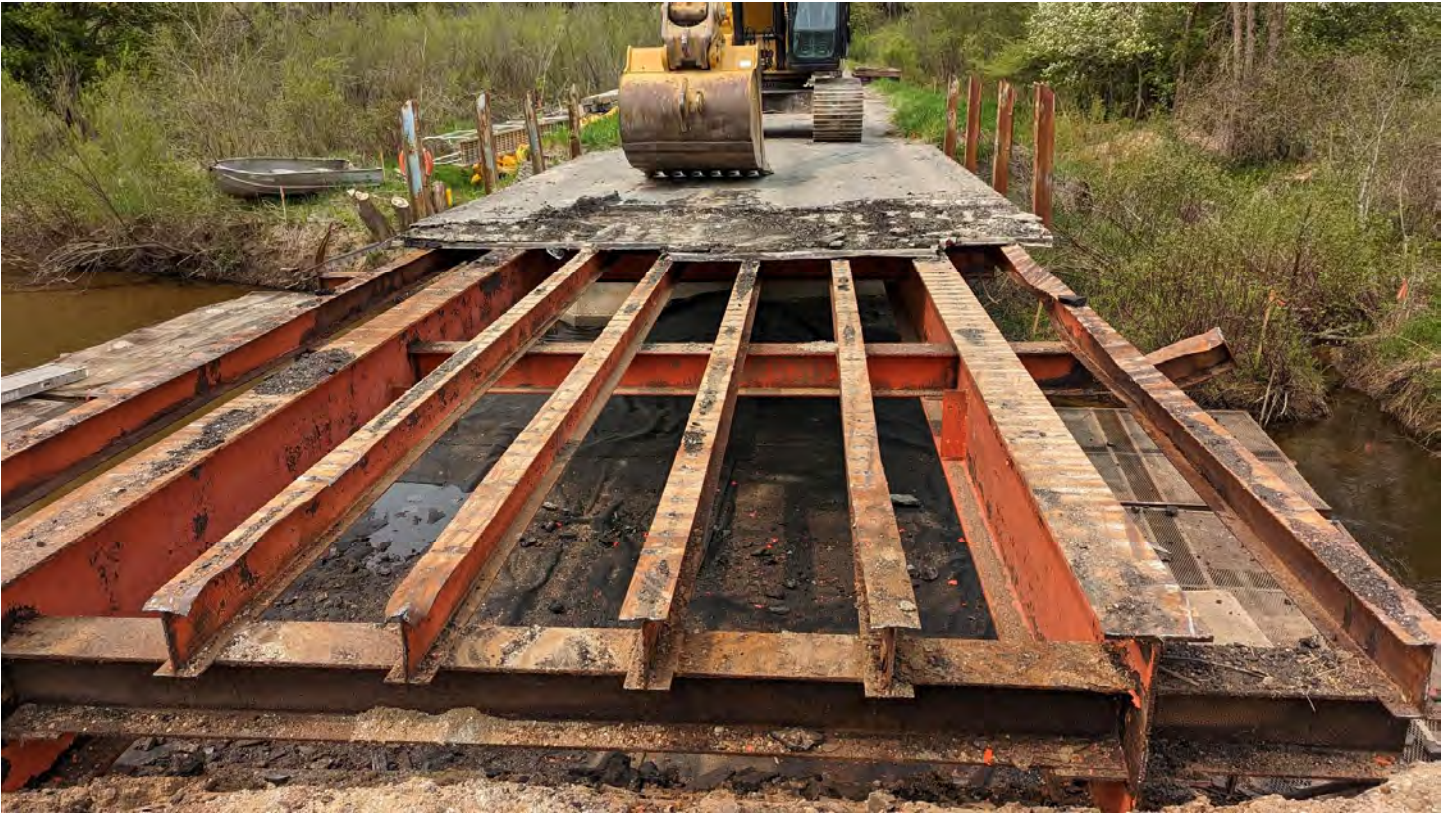
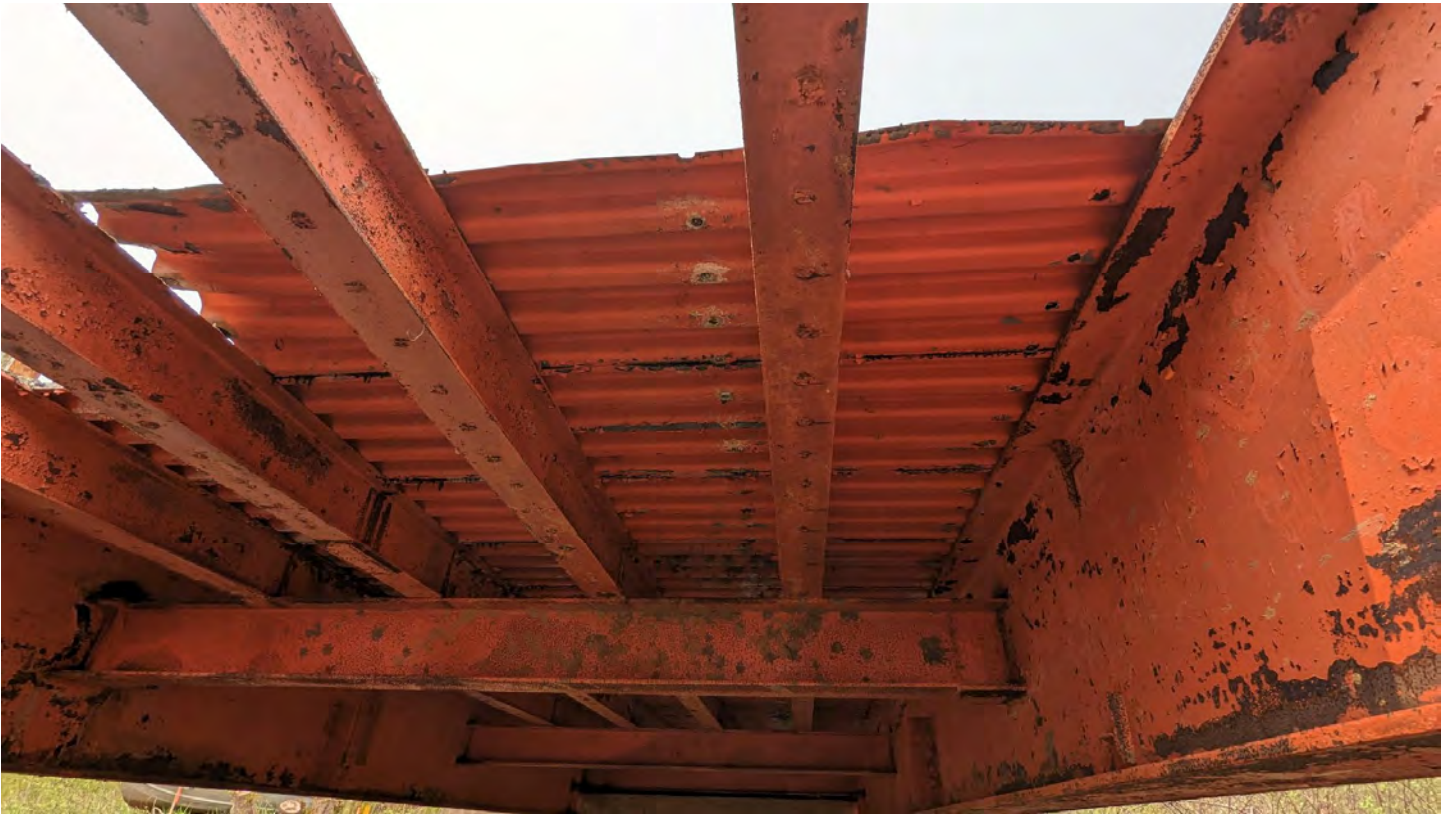
Under the Old Fisher Road Bridge looking up at corrugated metal deck

Existing Bridge Beams - From 1974

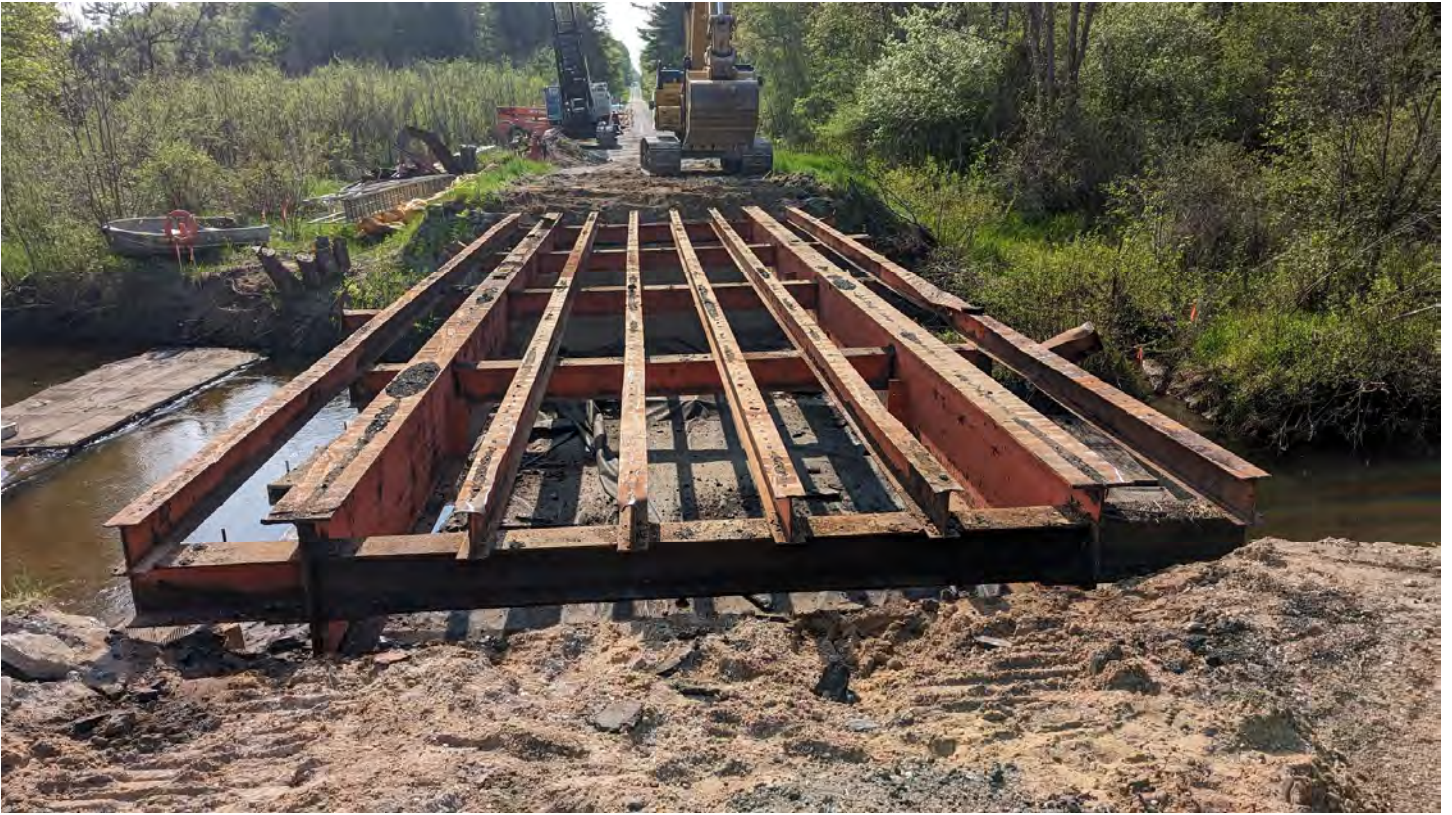
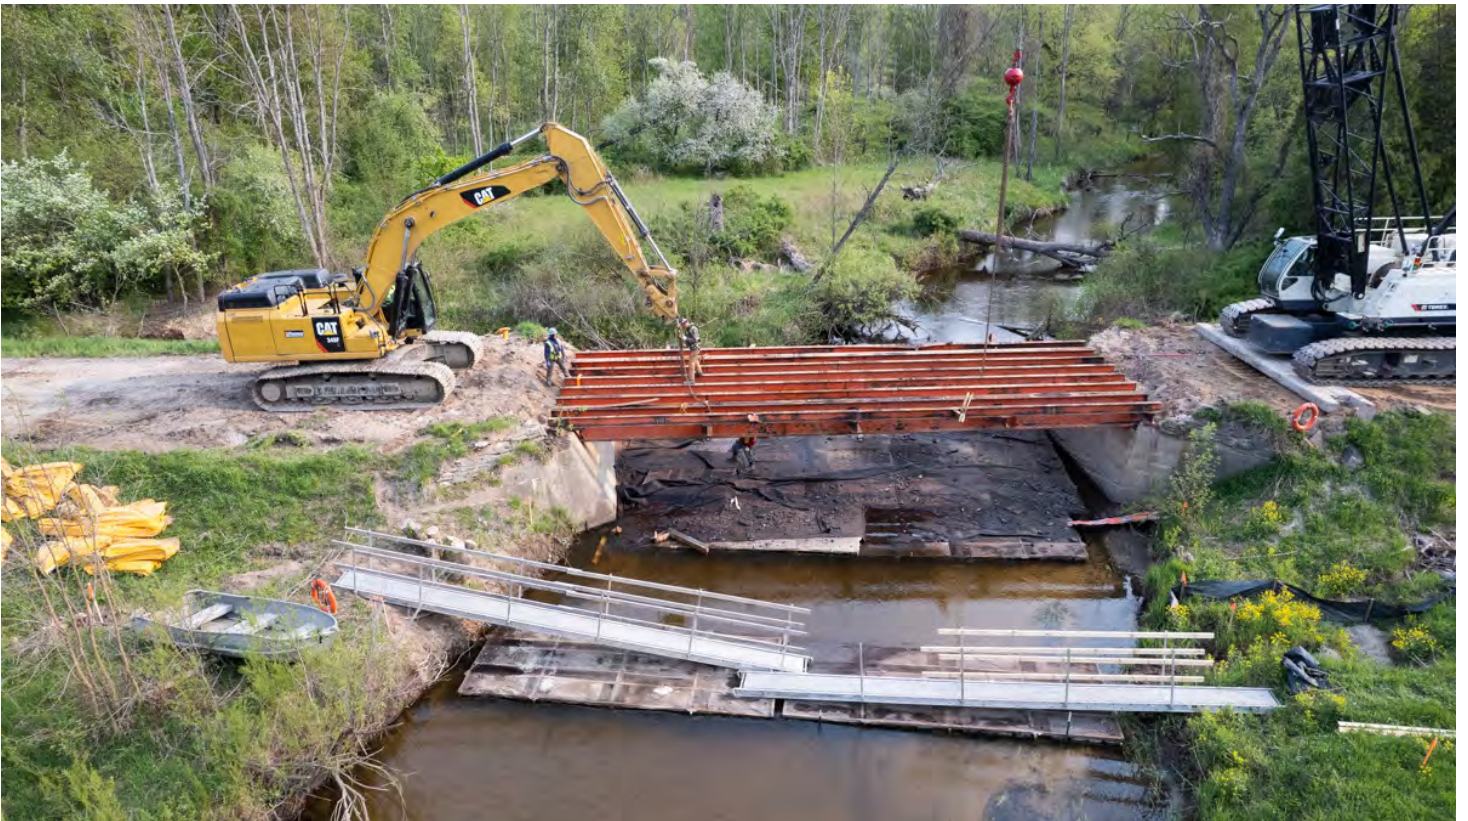
Removal of Old Bridge Beams - May 2023

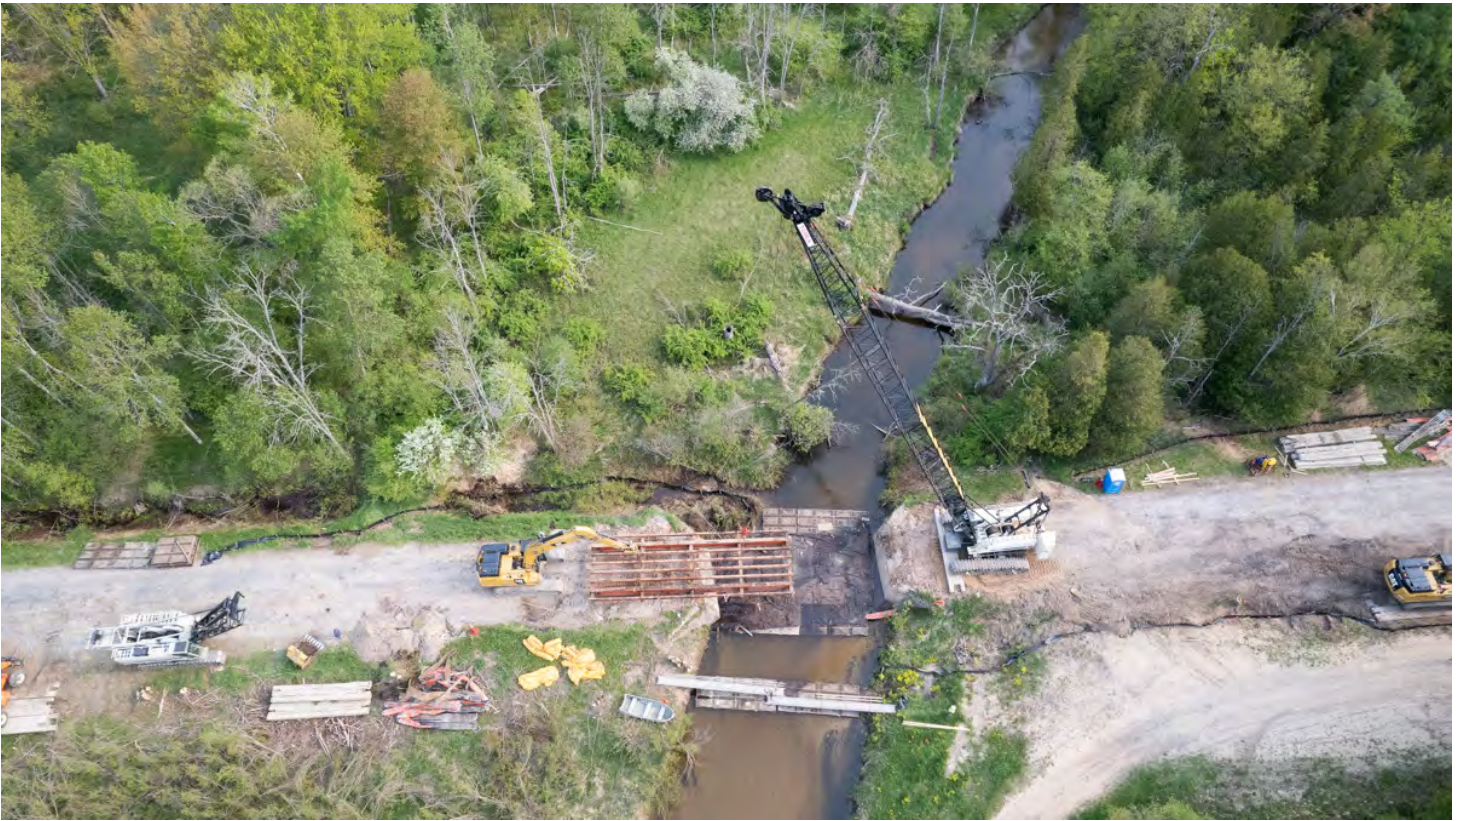
Installing Steel Sheet Pile Cofferdams - June 2023

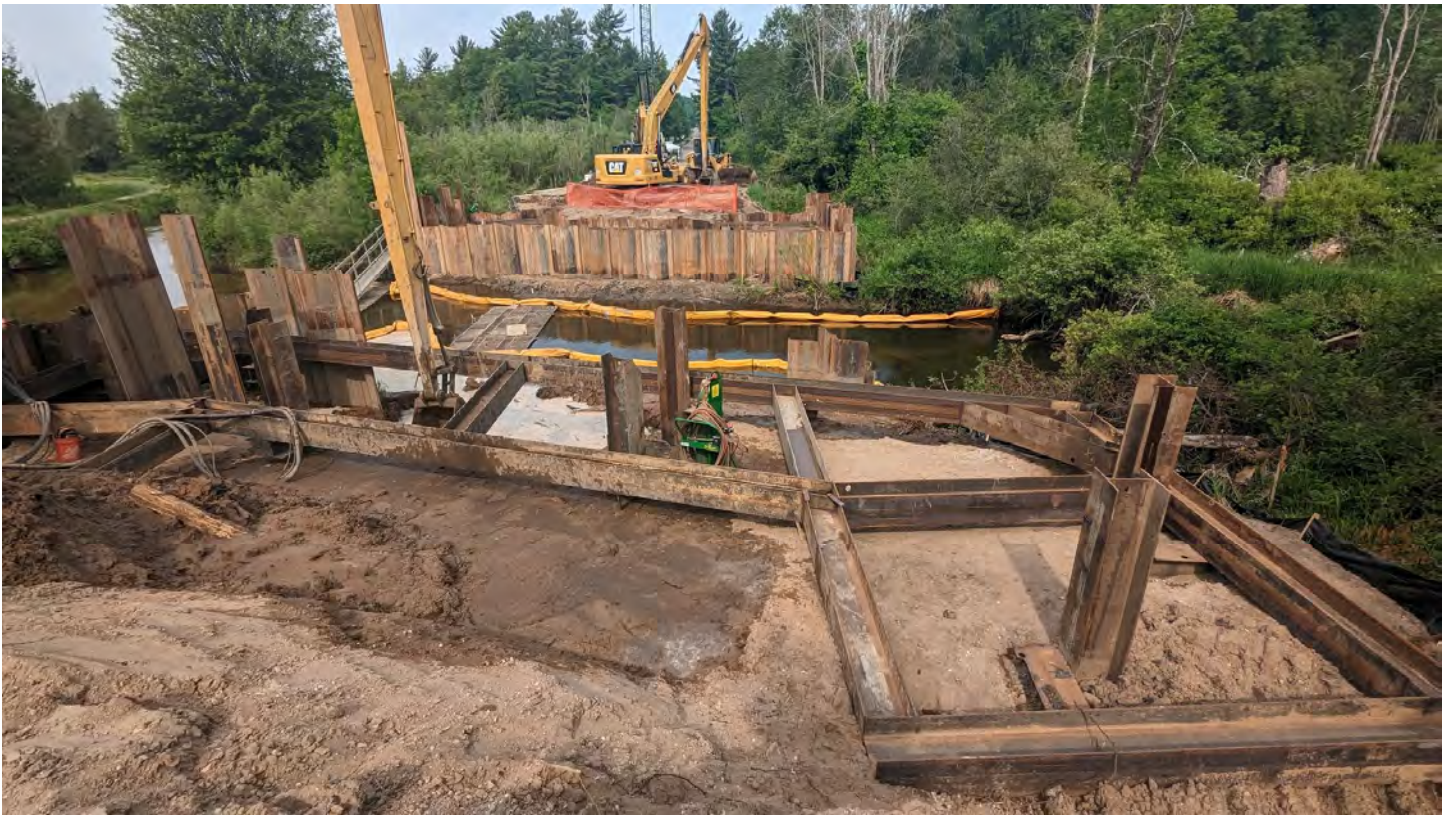
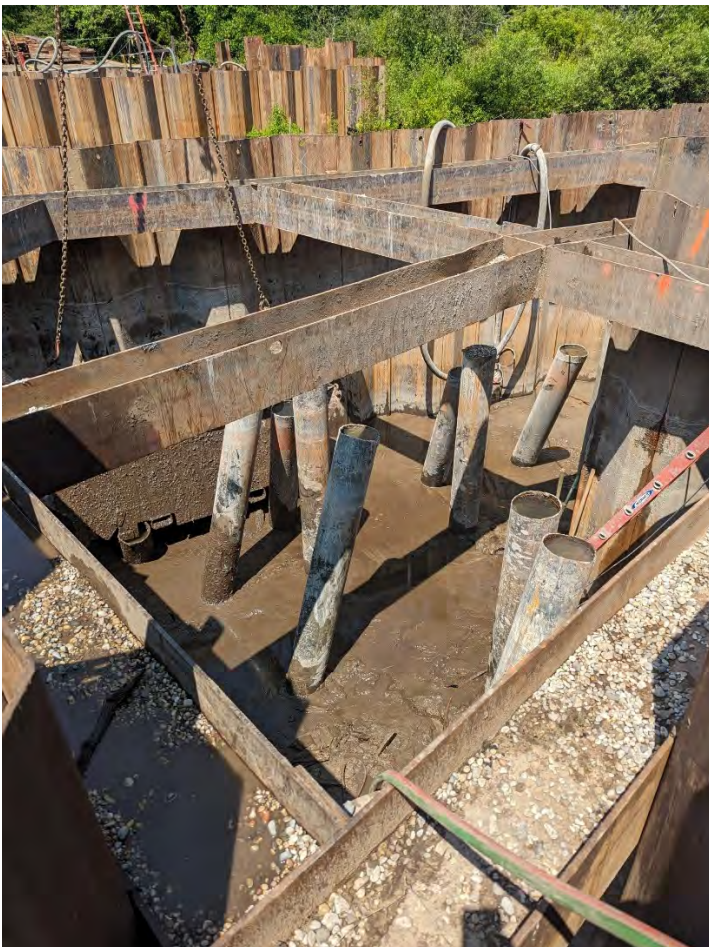
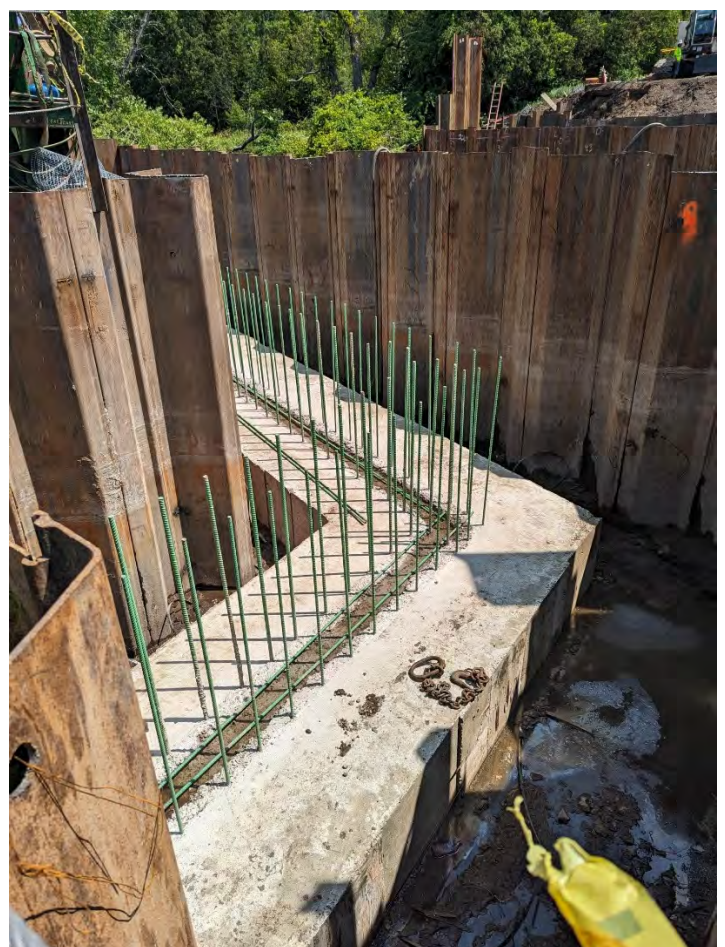
Support piles driven 60'+ deep to support the concrete footings

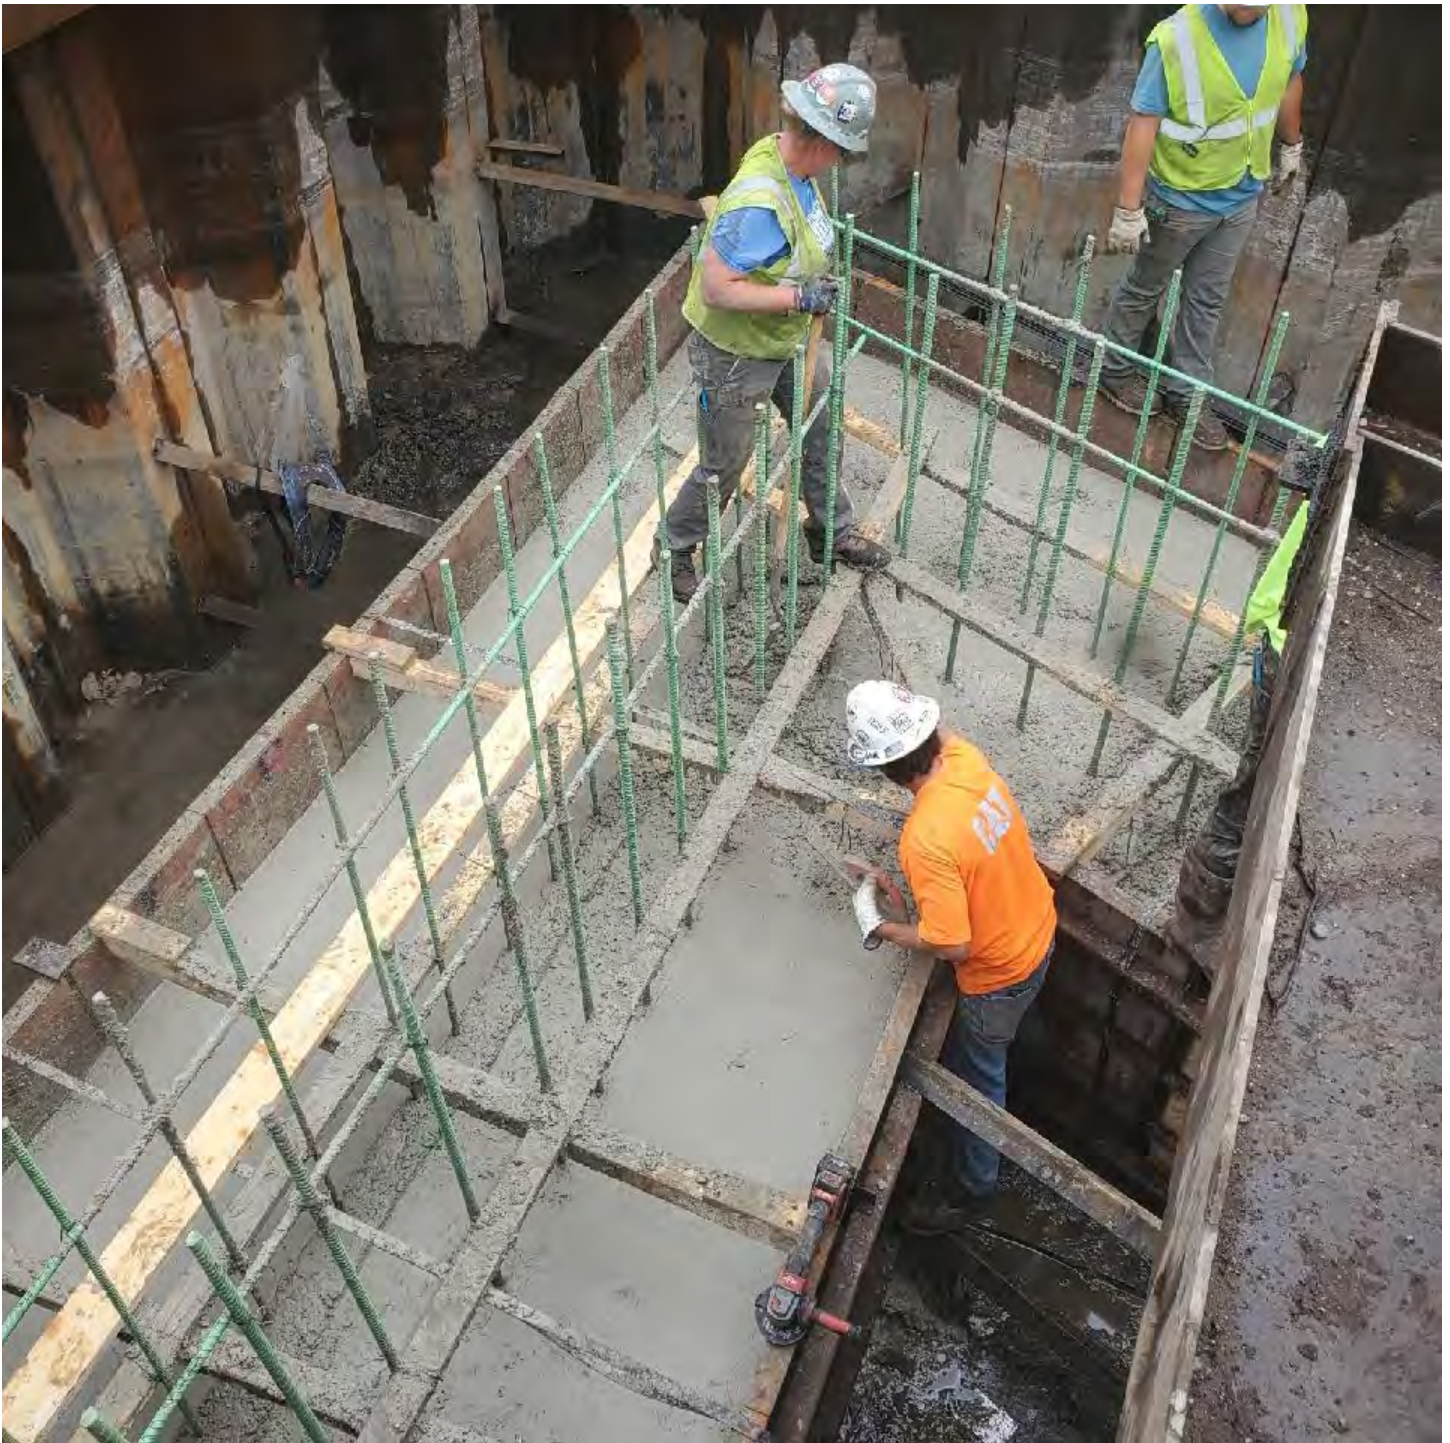
Pouring Concrete Footings over the steel piles

Pouring the concrete footings - July 2023

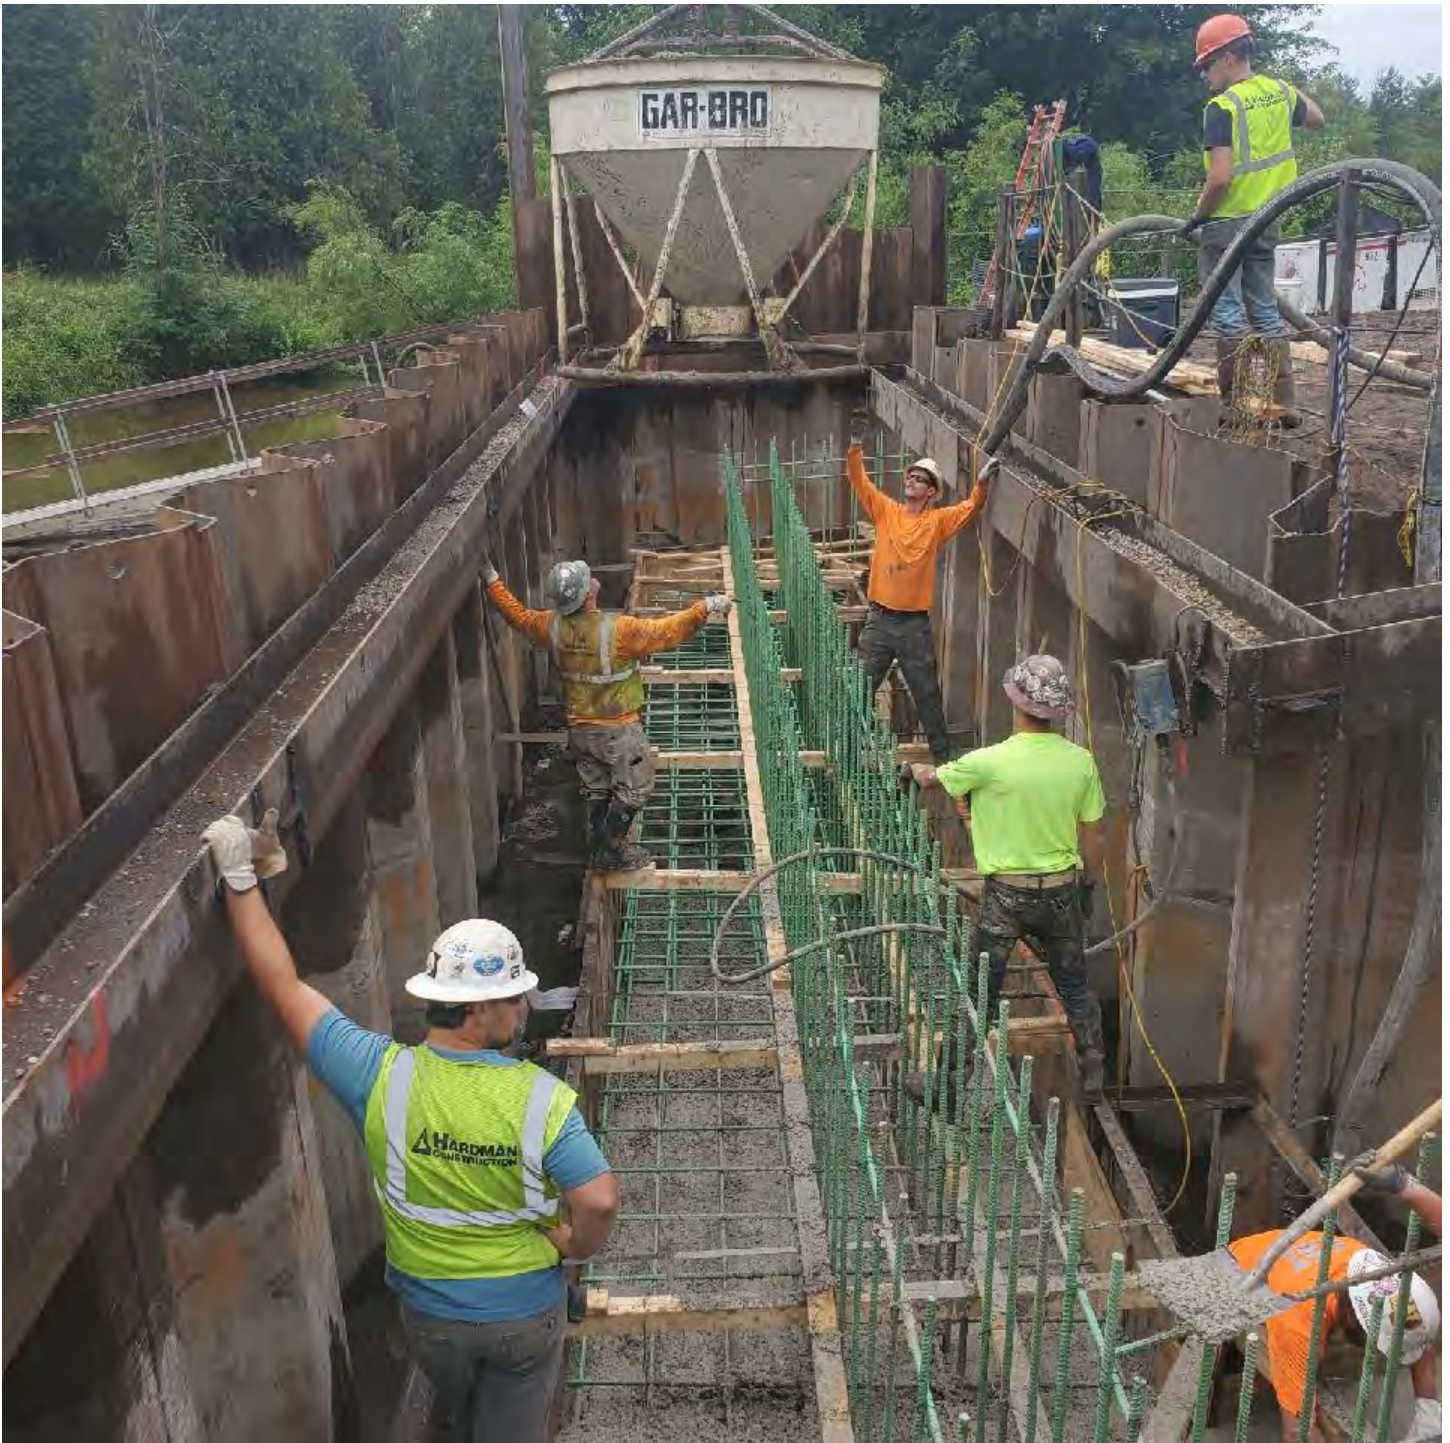
Setting the Tub Girder Beams - August 2023

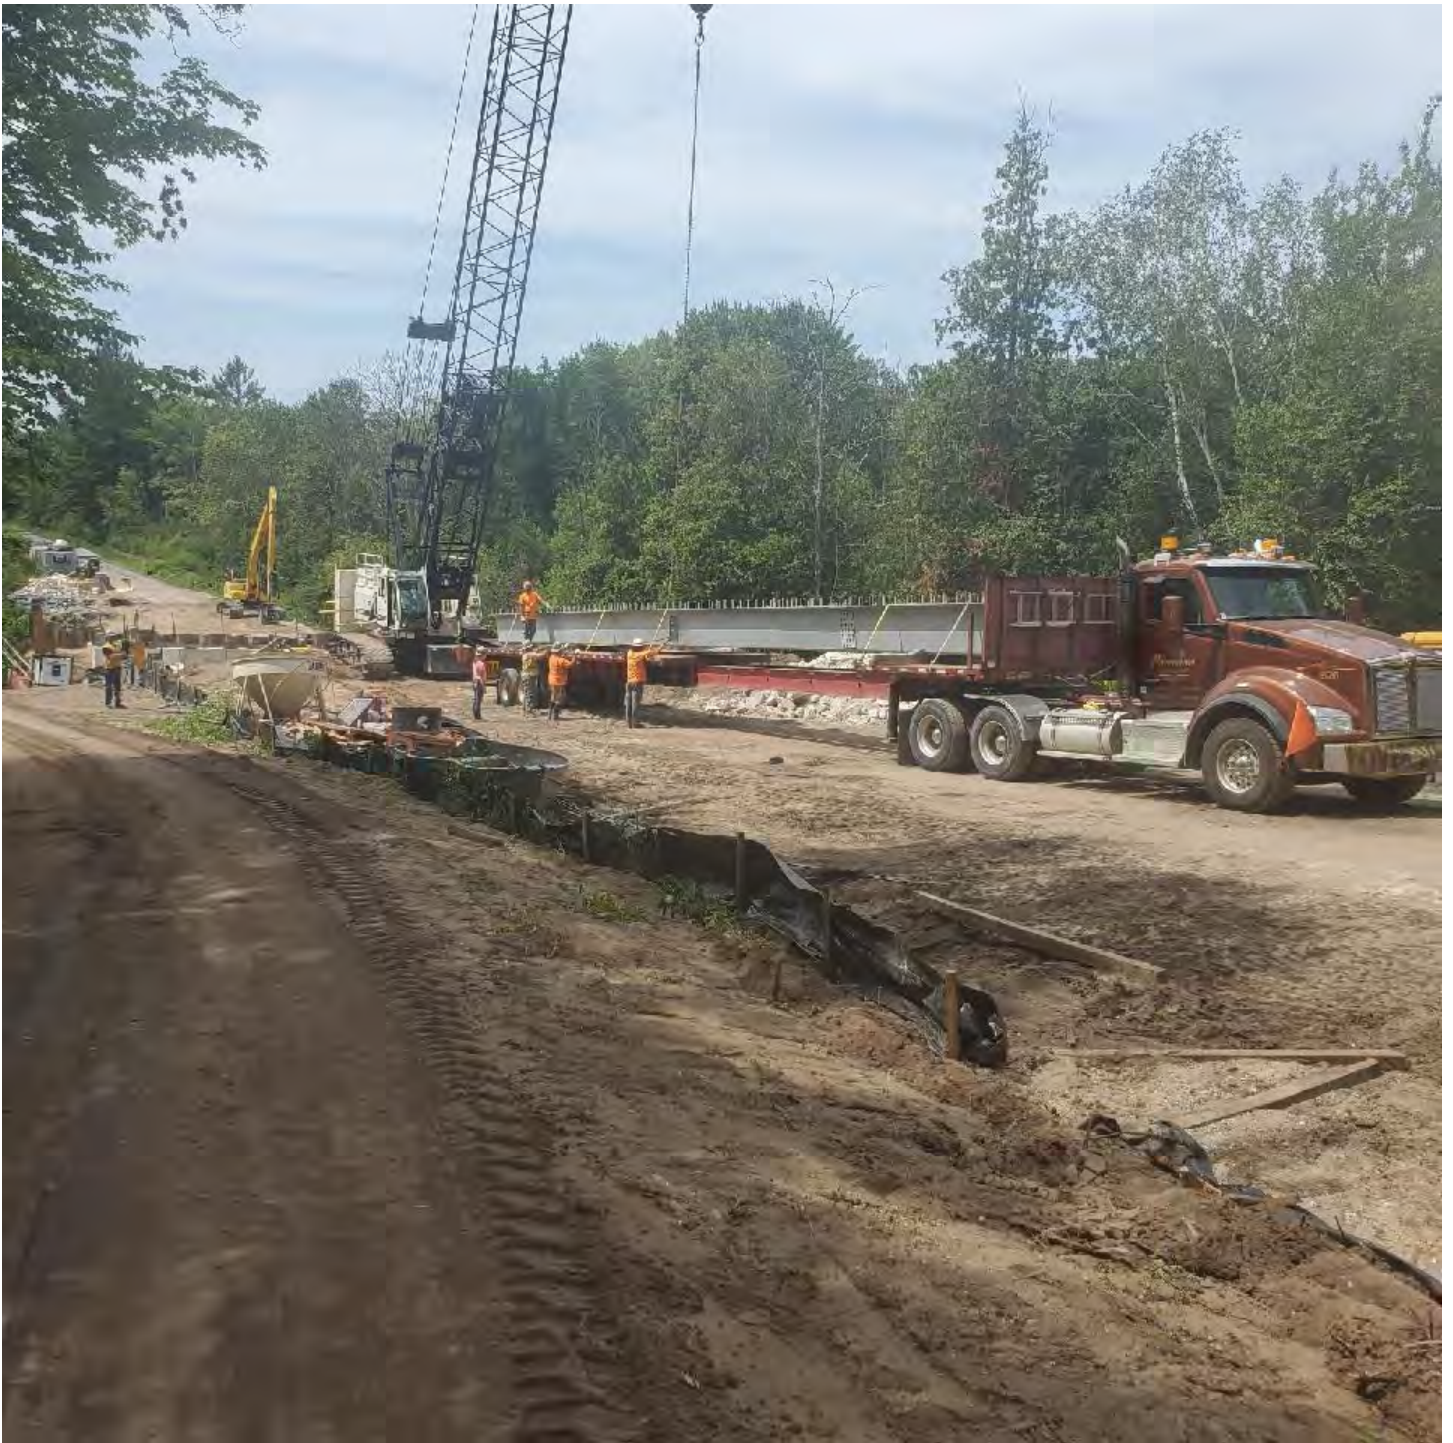
Setting Bridge Beams on concrete abutment walls - heavy rip-rap placed for scour protection
