Fisher Road Bridge - Between Peterson Road & Victory
Corner Road - Victory Township, Mason County

Existing Bridge - Built early 1900's - Replaced Beams & Deck 1974

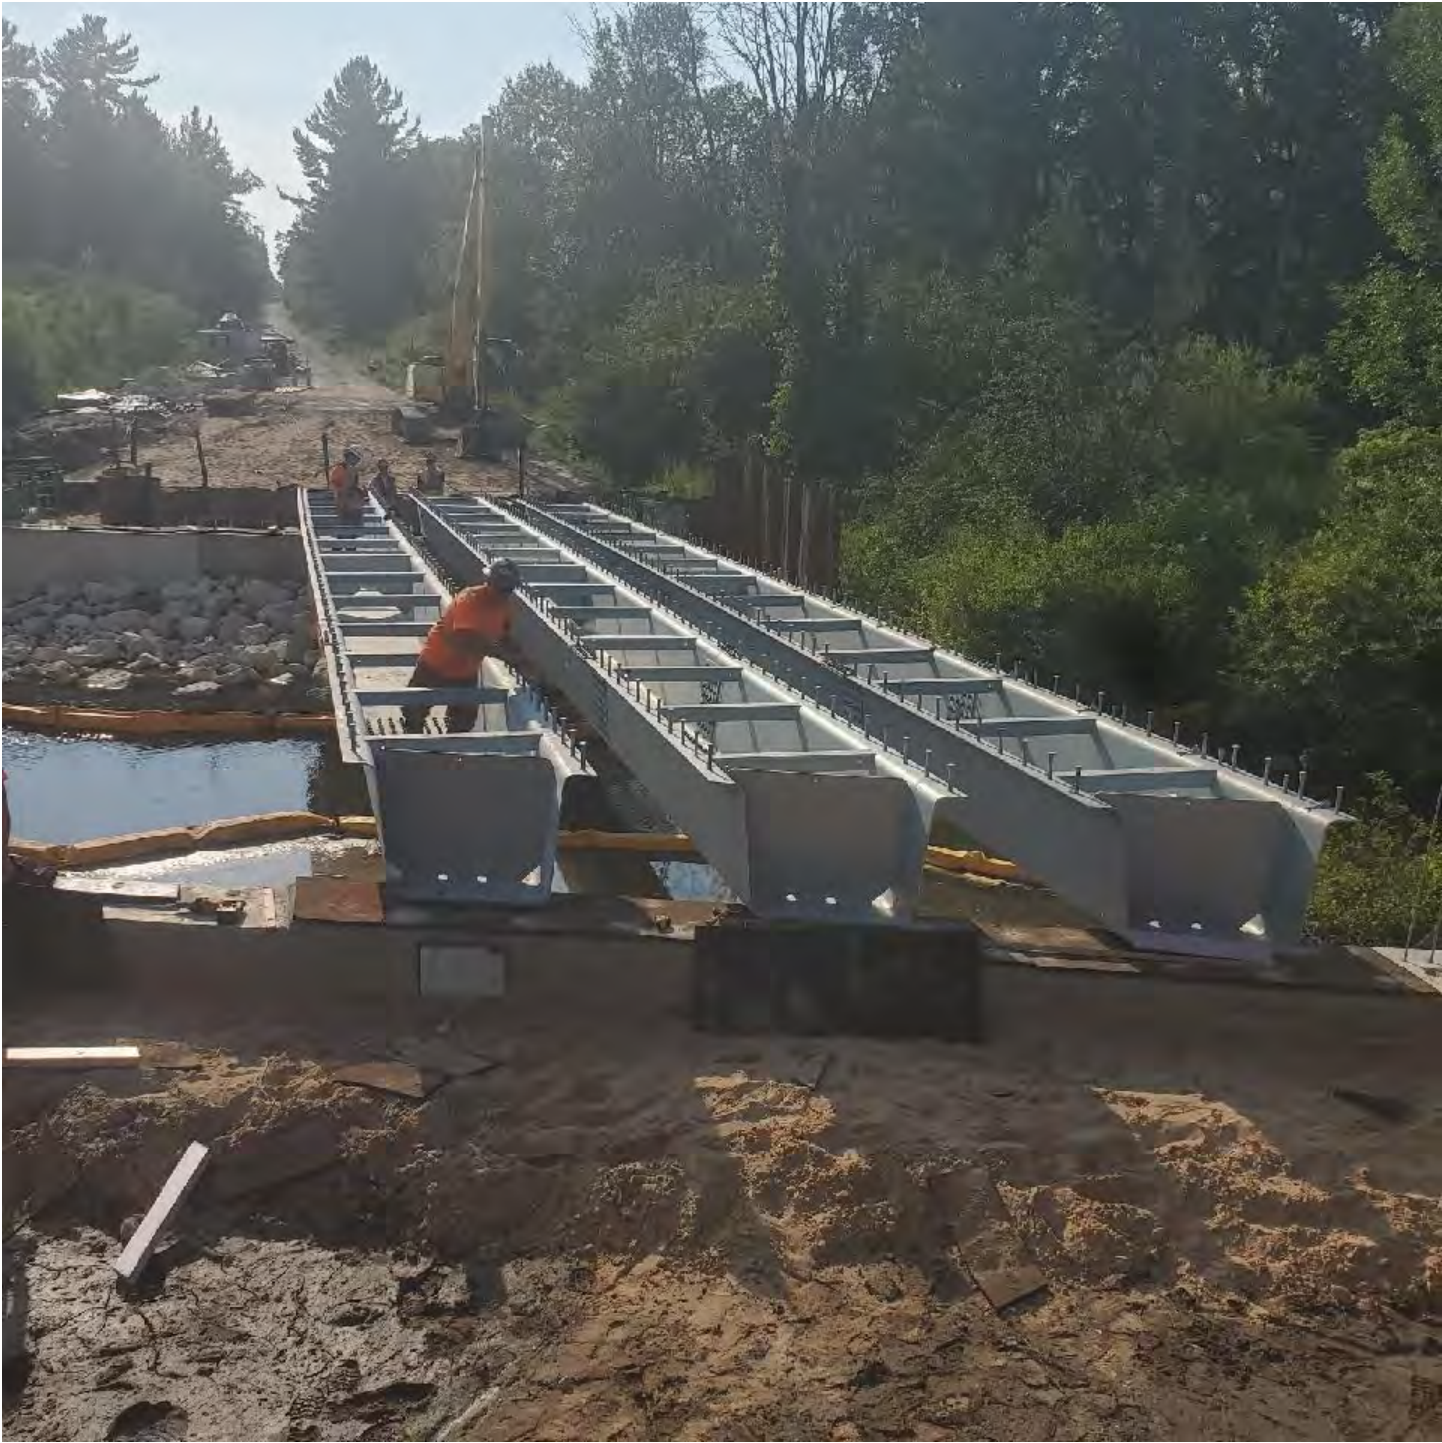
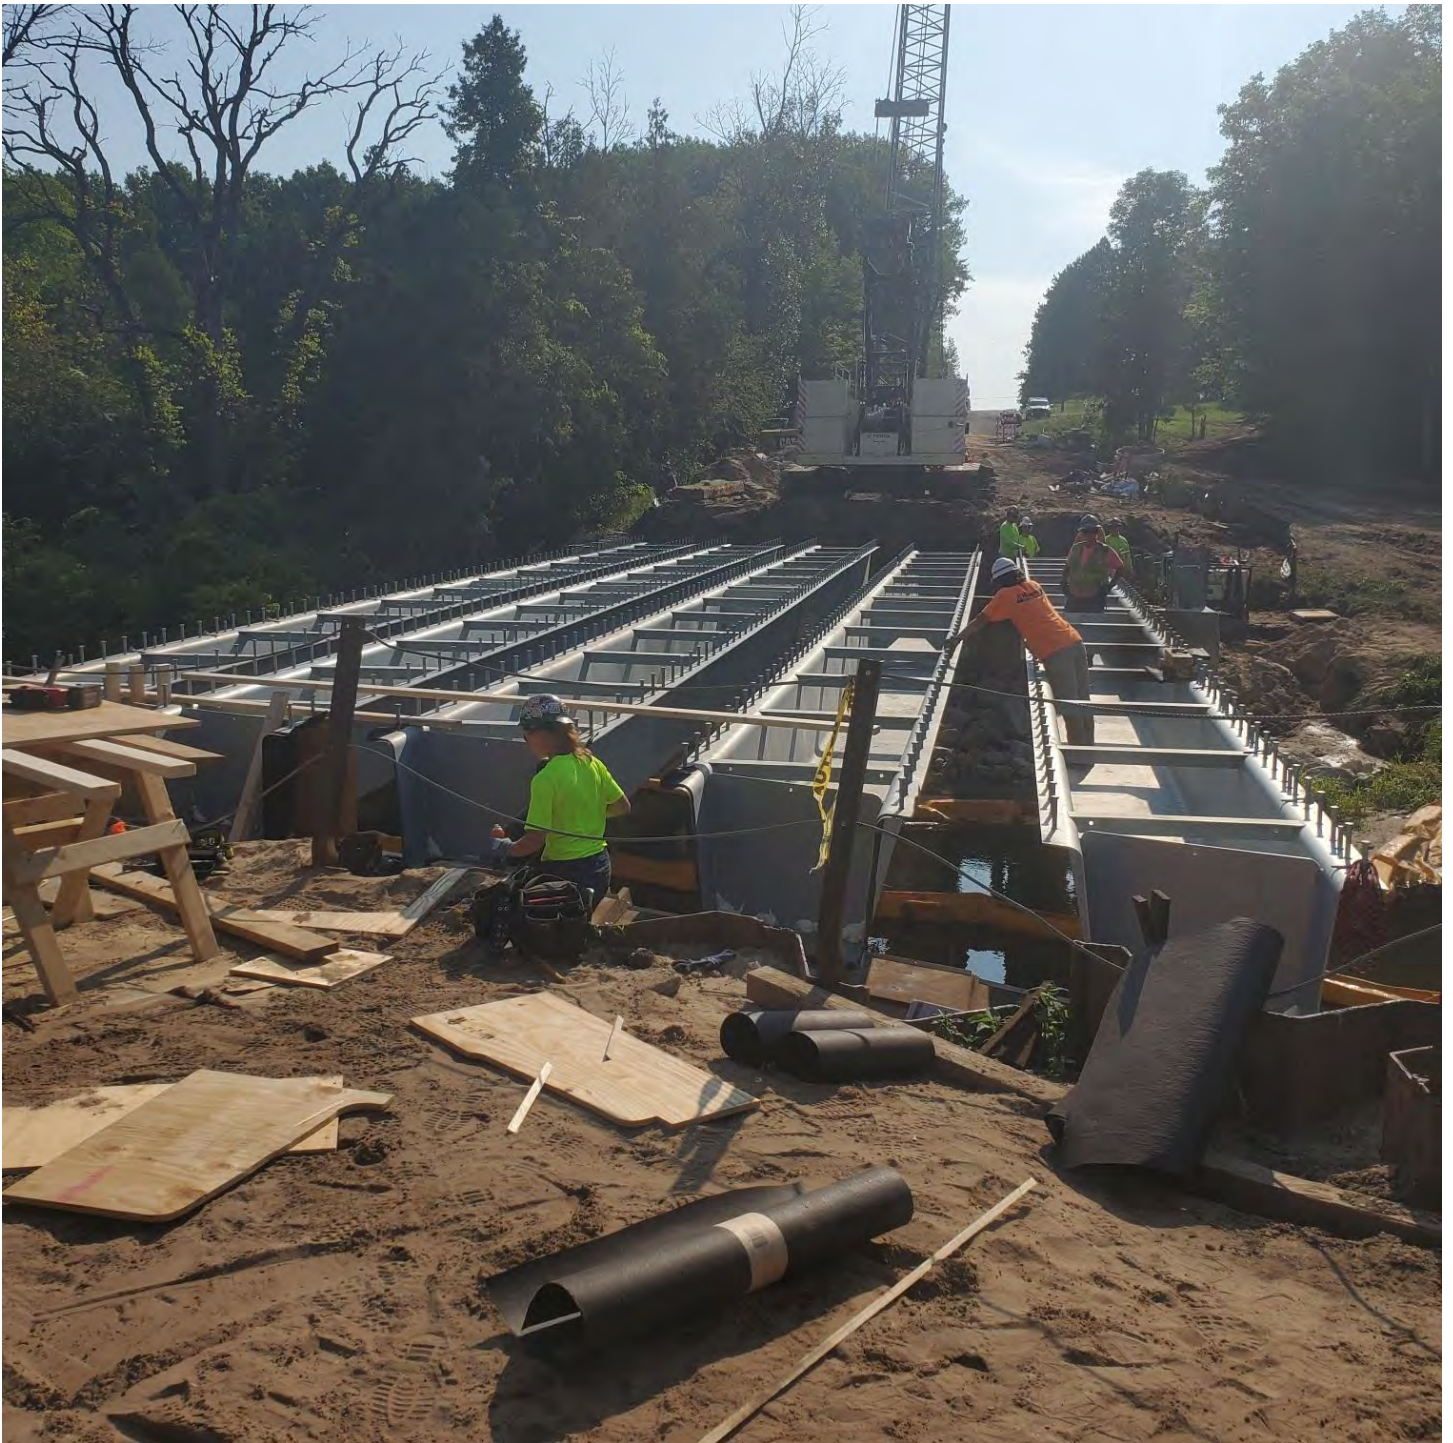
Five tub girder bridge beams set on concrete abutment walls

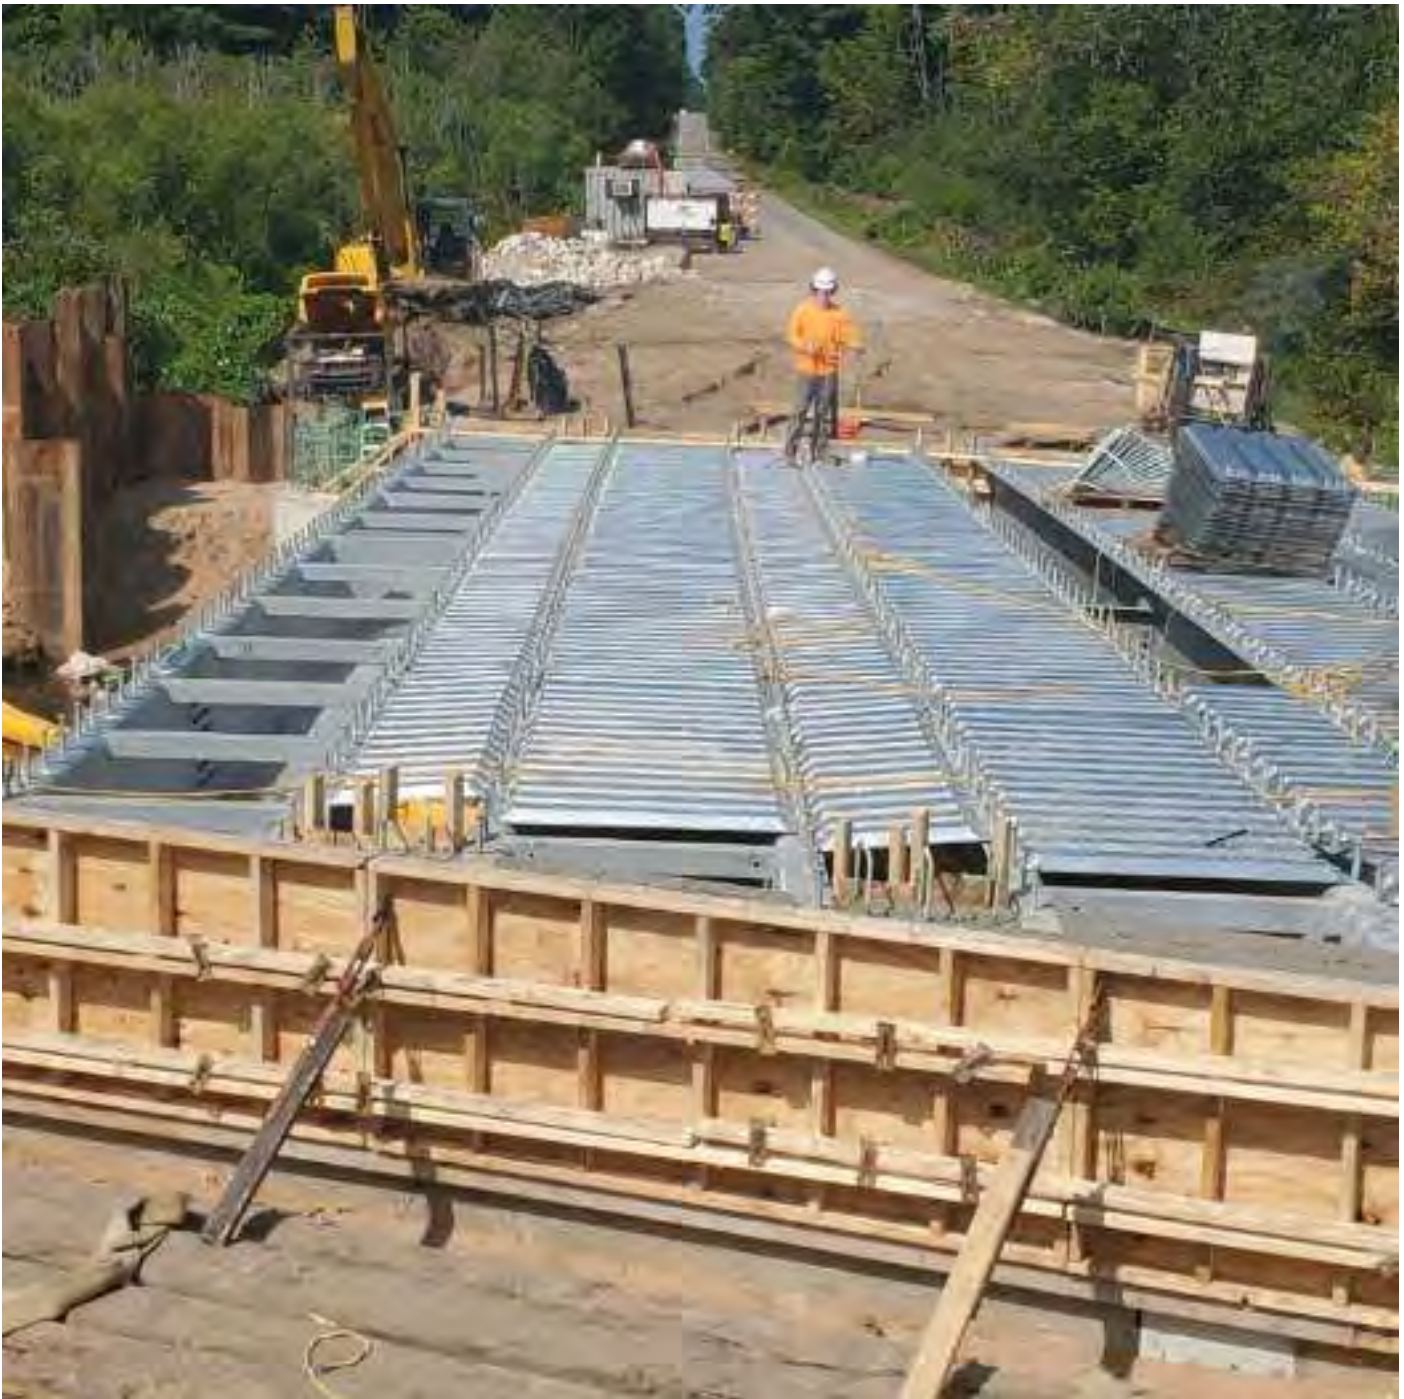
Pan Decking Installed on top of Tub Girders - August 2023

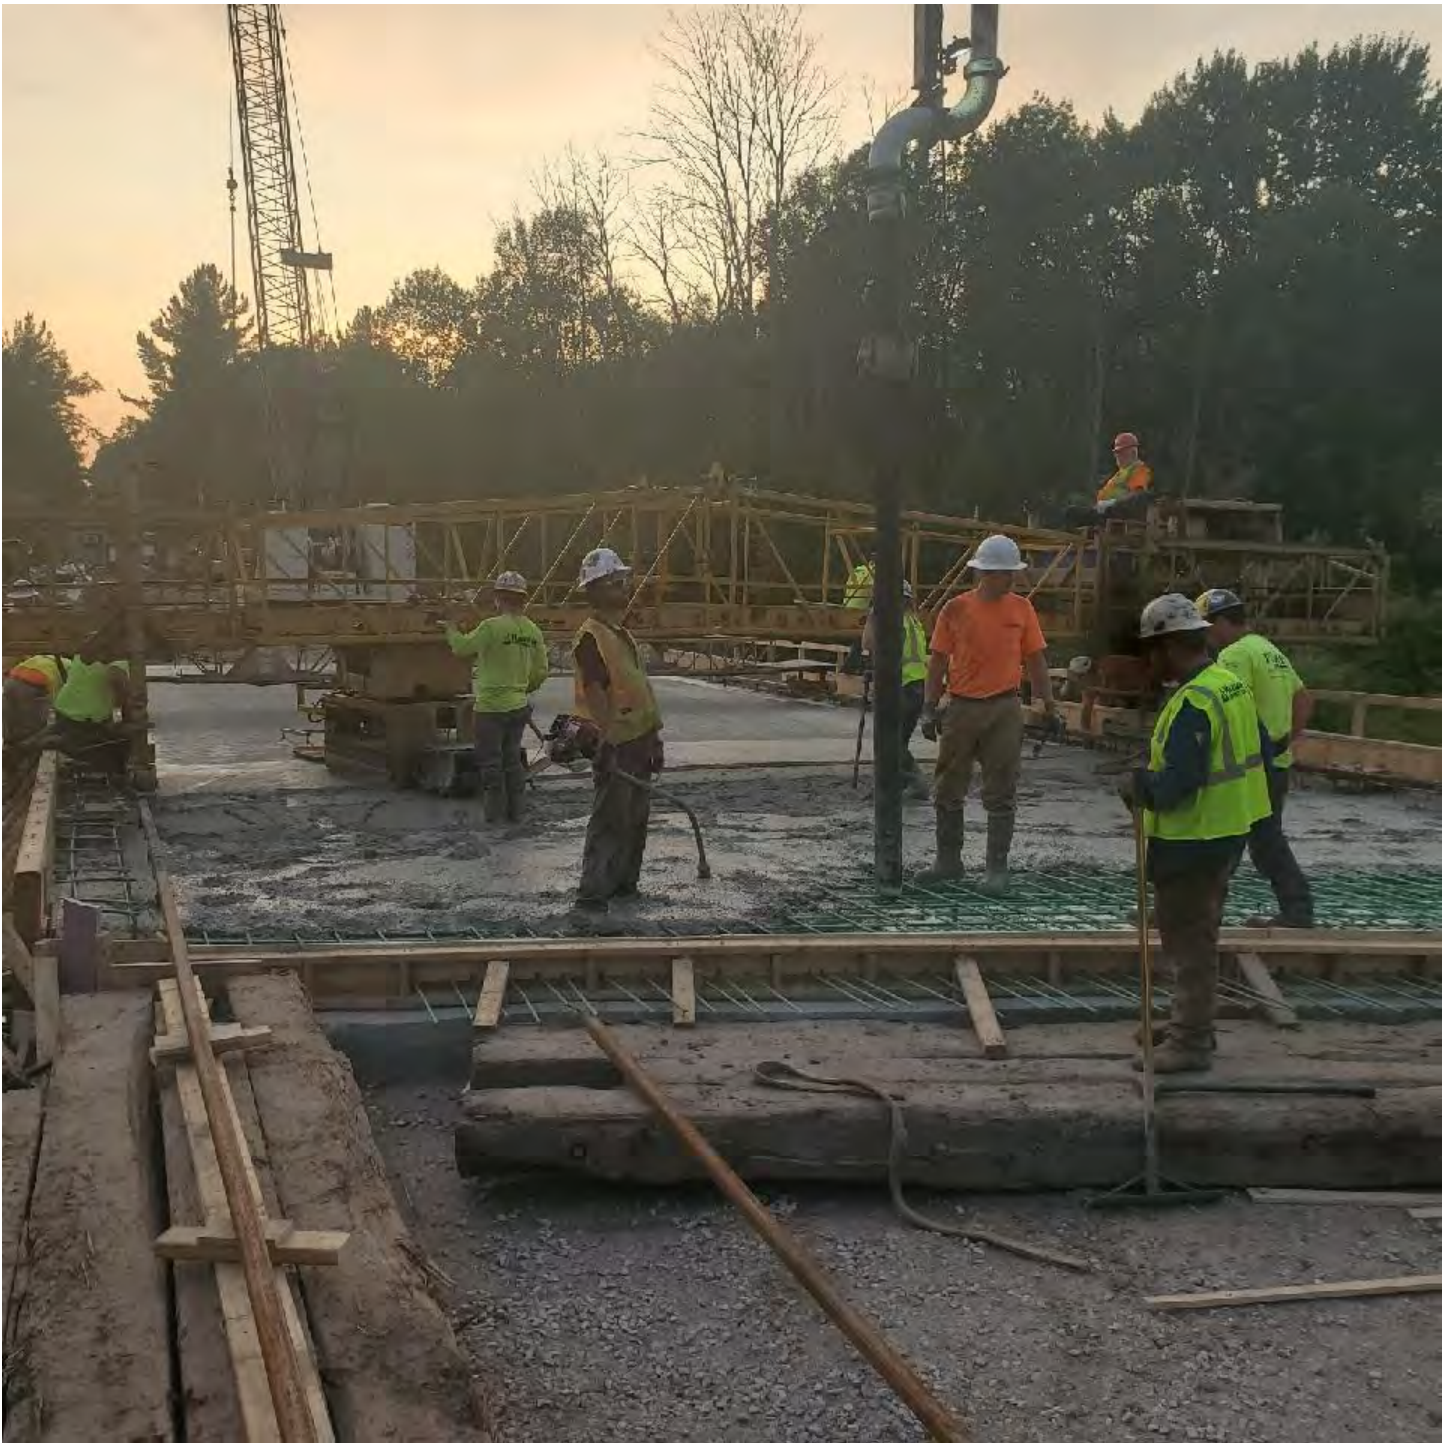
Concrete Deck Poured - Late Evening/Night to reduce cracking

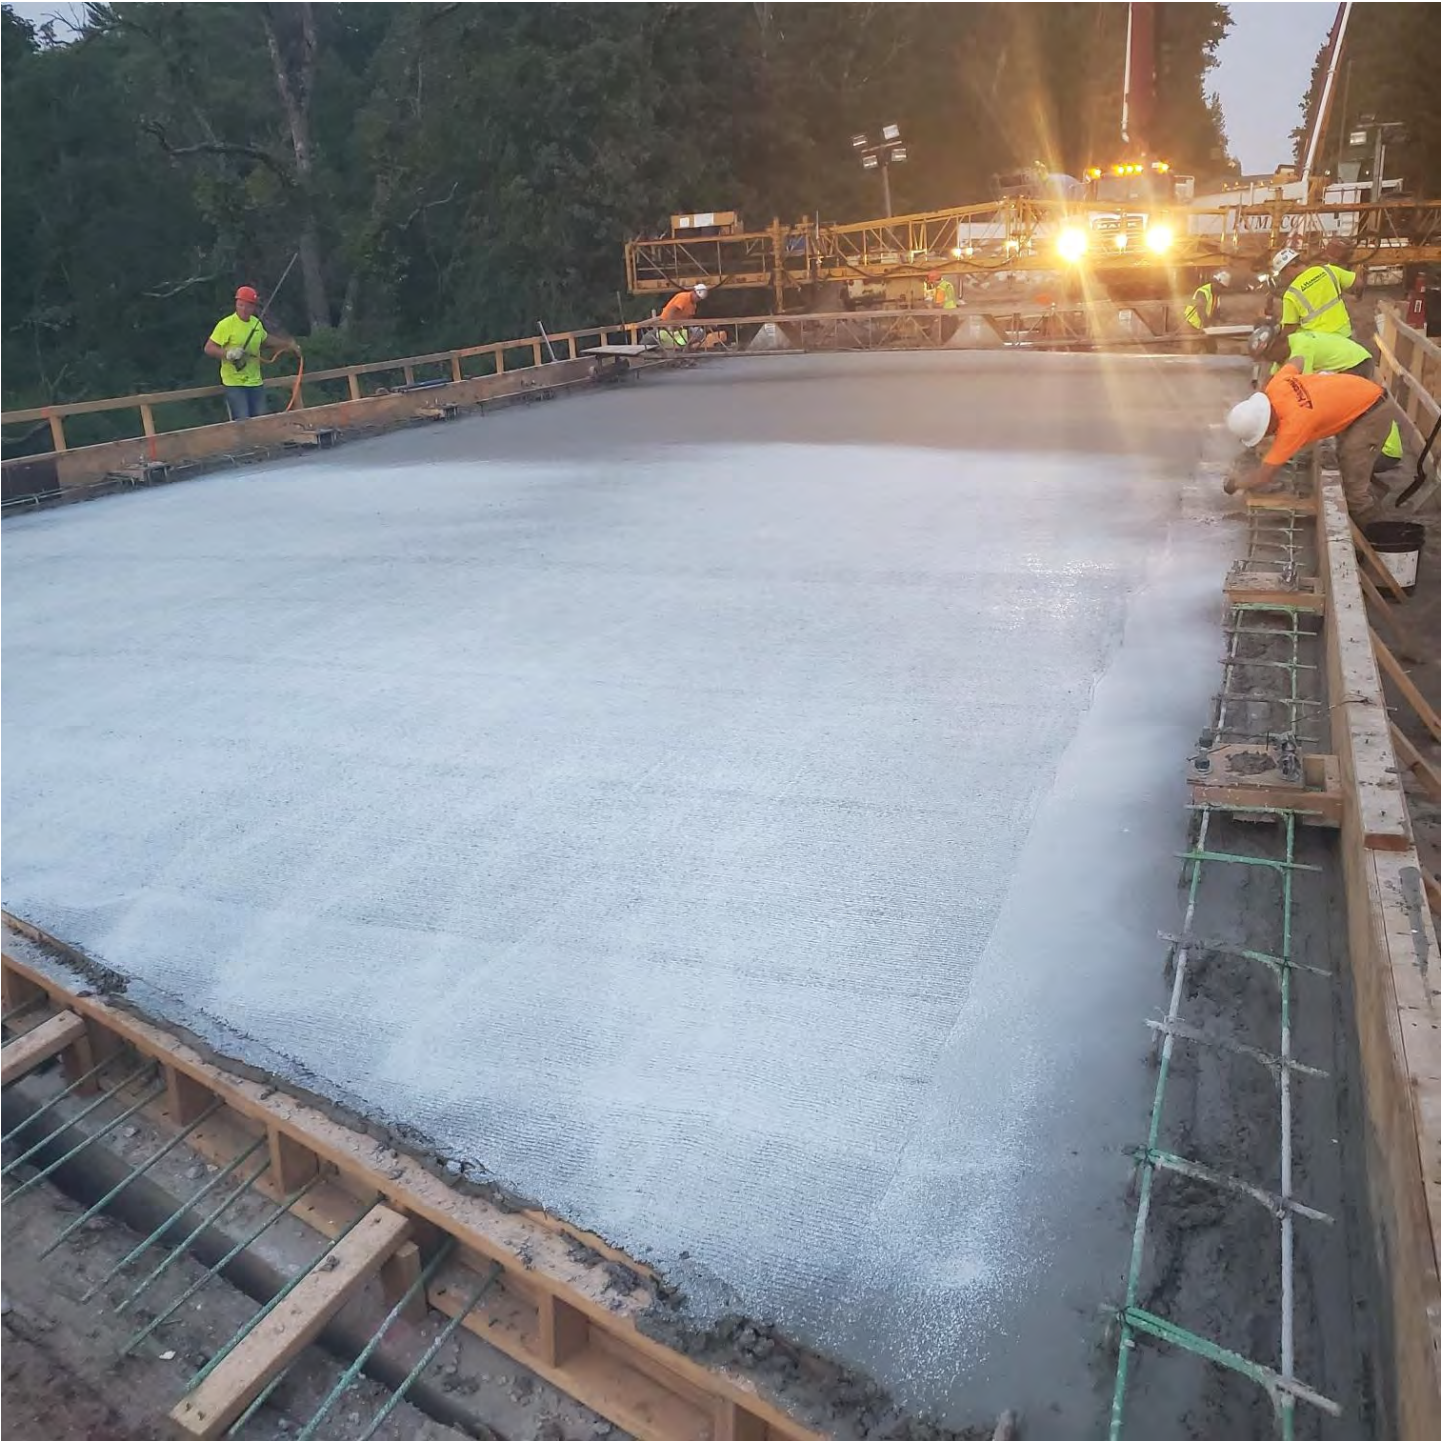
Curing Compound applied to concrete to reduce evaporation of the concrete which reduces cracking & increases the strength

Light plants used for finishing the concrete deck after sunset

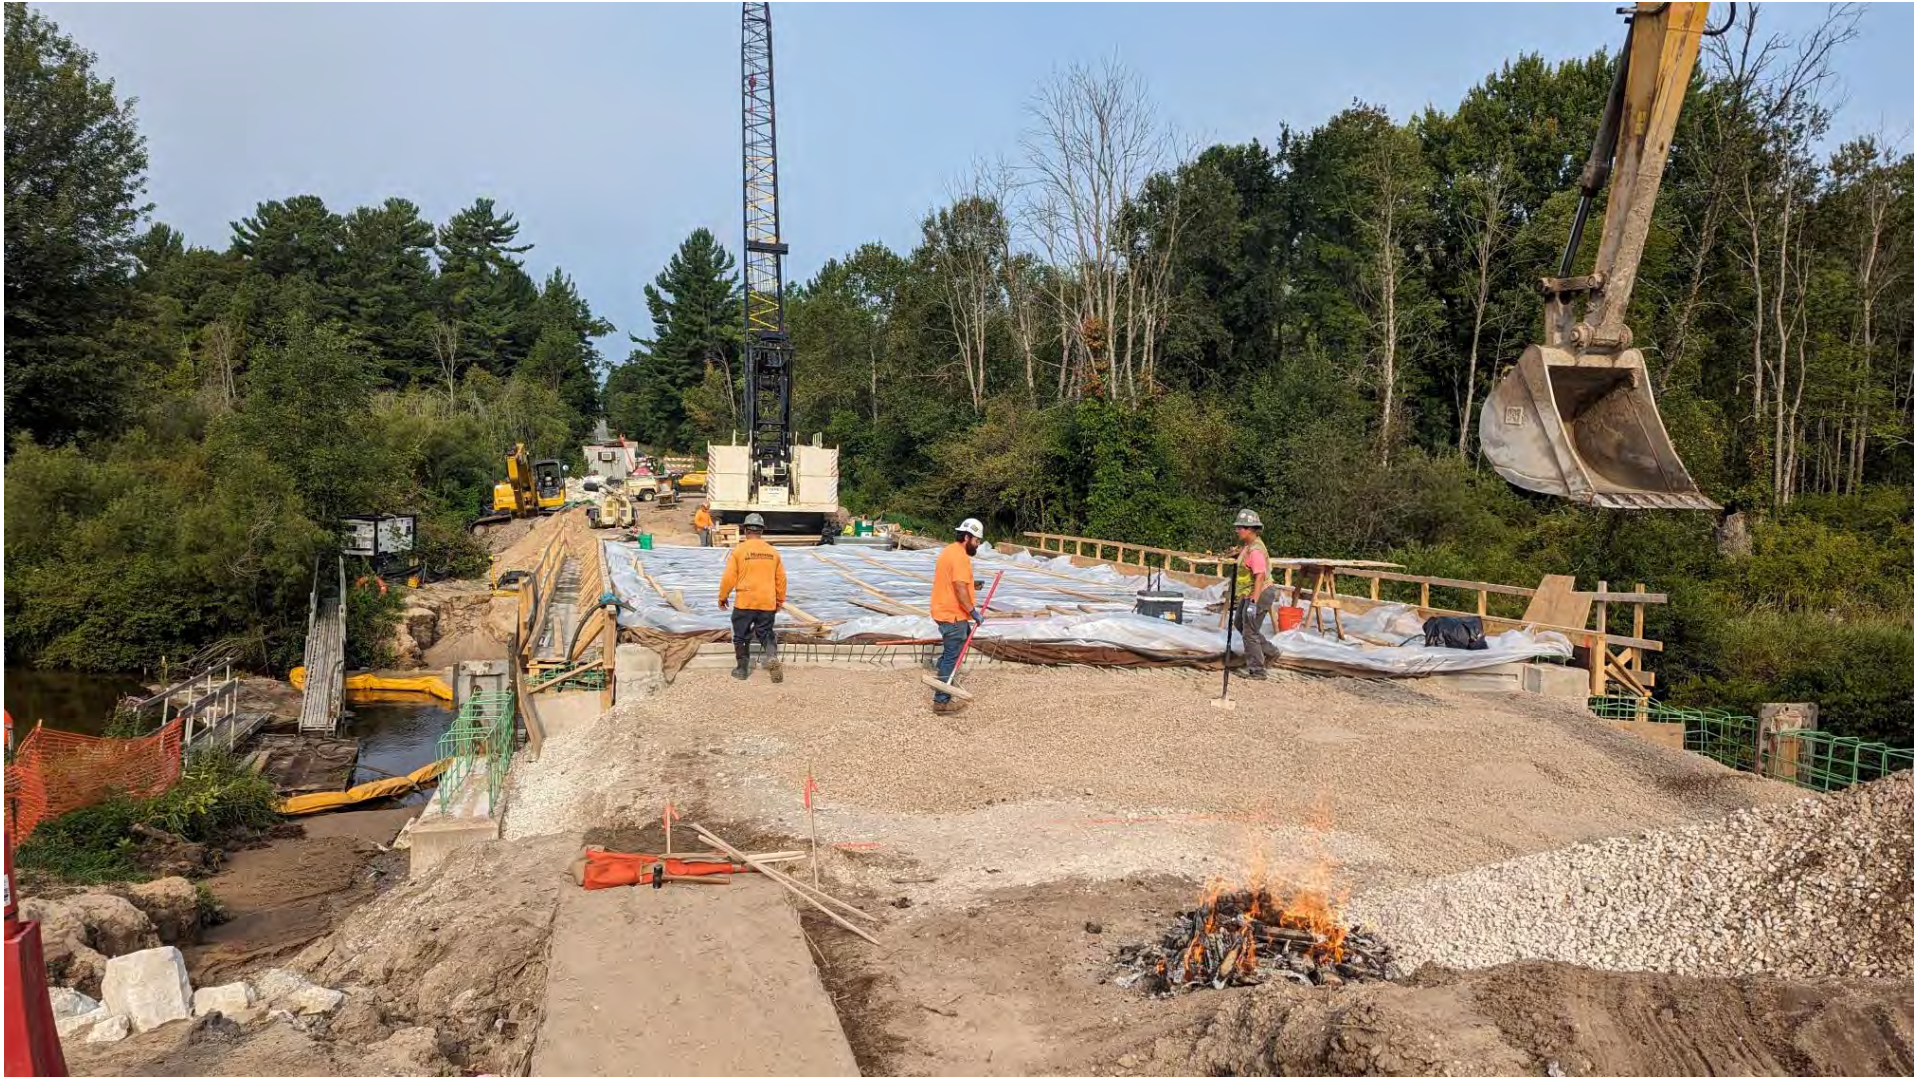
Preparing grade for concrete approach slabs - August 21, 2023
